Recent Projects

Paseo Bridge Pier Demolition

By David Hersey

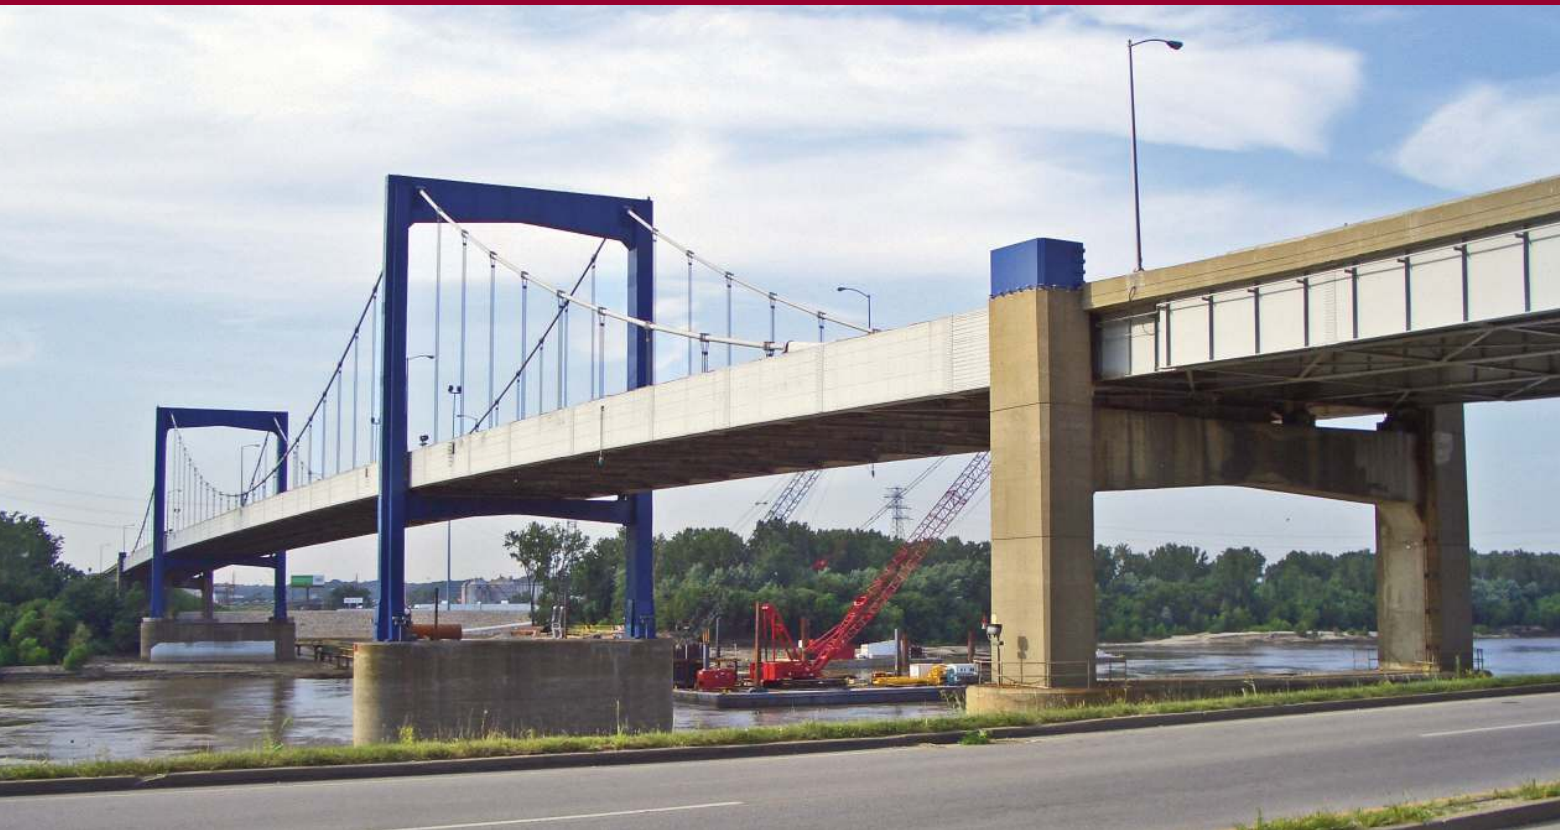
Figure 1. The old Paseo River Bridge before construction.

The Paseo Bridge was located at the I-29/I-35/US-71 Missouri River Highway Crossing. It was built between 1952 and 1954 by Massman Construction Company. The 1,232 foot long, self-anchored suspension bridge was the longest of its type when built. On Jan. 22, 2003, a connector pin designed to allow the bridge to expand and contract during temperature cycles seized and caused a portion of the bridge deck to raise up and block traffic. This marked the beginning of the end for the old Paseo Bridge.

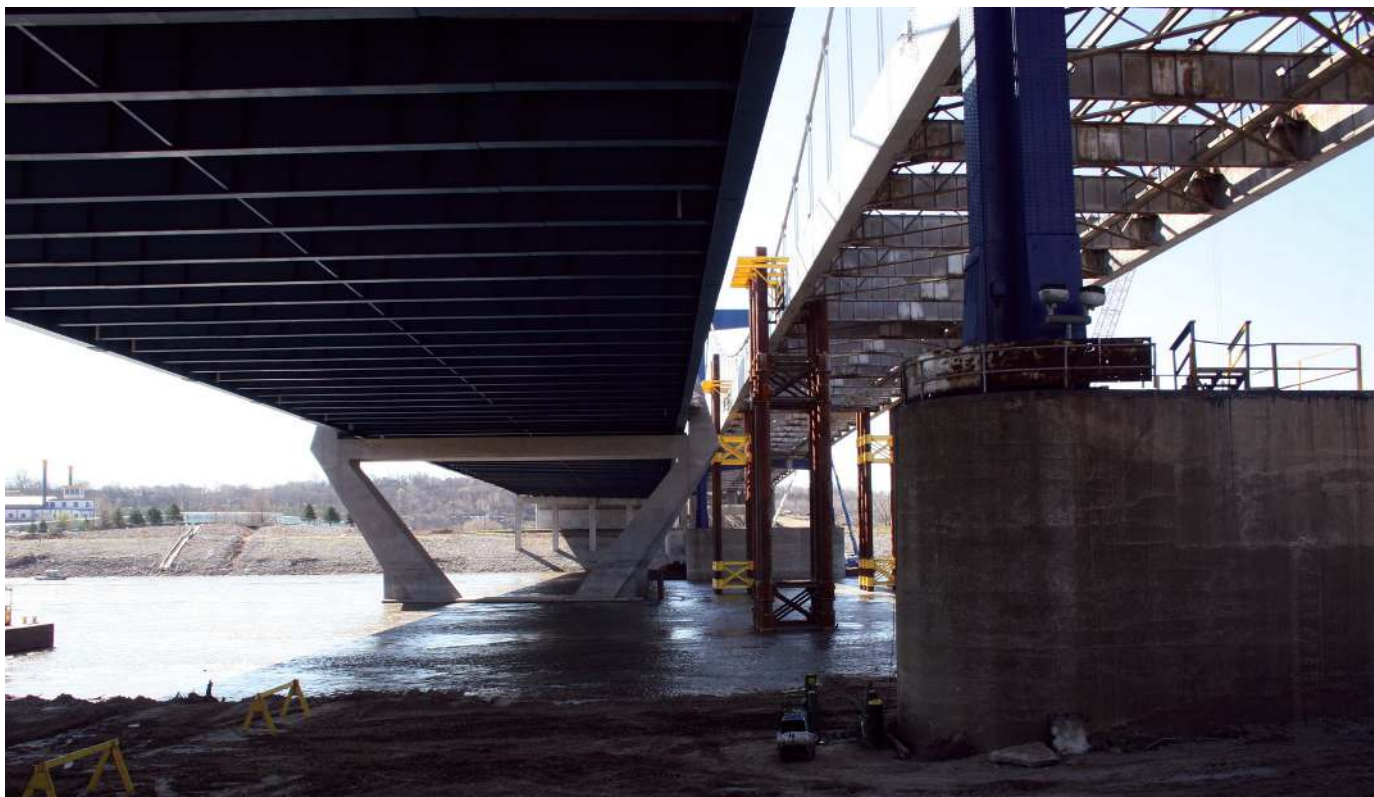
Figure 2. The old Paseo Bridge and new Christopher S. Bond bridge, before the old bridge was taken down.

sented some unique challenges as well. The Paseo bridge was one of only two remaining self anchored suspension bridges left in the United States and it was setting within 6 feet of the new Bond Bridge. It was necessary to dismantle the bridge in the reverse order in which it was originally constructed.

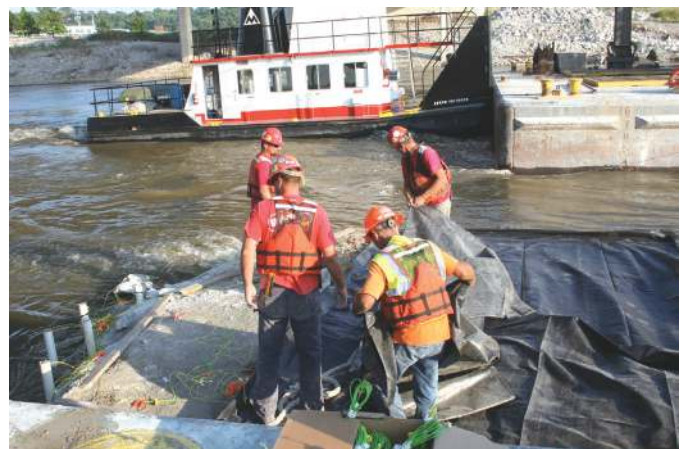
Figure 7. Placing the geotechnical fabric.

various cavities and hollow areas were carefully logged and cased to allow for the proper placement of the explosives. Once this was completed, the entire pier surface was covered with geotechnical fabric and several layers of woven chain link fencing to protect the nearby operational bridge from damage.

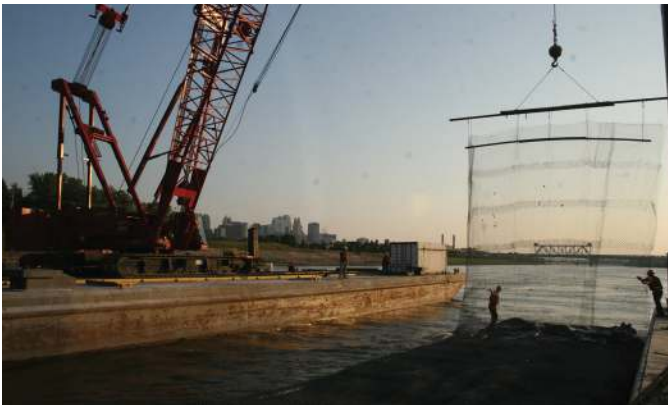
Figure 8. A woven chain link fencing was placed on the pier surface to protect the nearby bridge.
